AP7-11 Trawbreaga

Visual Impact Report – Aquafact

Landscape and Visual Impact Assessment

for Proposed Oyster Trestles in

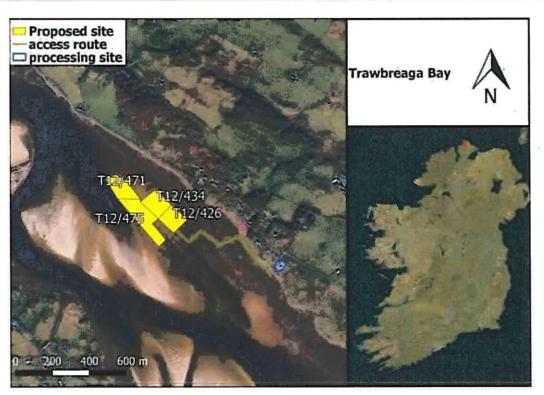
This assessment focuses on four adjacent proposed oyster sites located in Trawbreaga bay (Figure 3.1), licence numbers T12/475 (22000m²), T12/471 (12684m²), T12/434 (12850m²) and T12/426 (11400m²). The typical trestle method is proposed and this is constructed of 16mm steel bar with plastic oyster bags secured on top. Trestles are 0.6m high with a width of 1.3m at the base tapering to 0.8m at the top. Oyster bags are placed length ways across the trestles at a width of 1m. Trestles are arranged in rows of up to 100m in length to fit within the licence area and rows are spaced 4m apart. The trestles are located at low water Spring tides and so are only accessible or visible during the latter period of low water when this occurs in daylight hours. Access will be by tractor via existing routes and an existing processing area will be used (Figure 3.1).

Figure 3.1 Proposed site location.

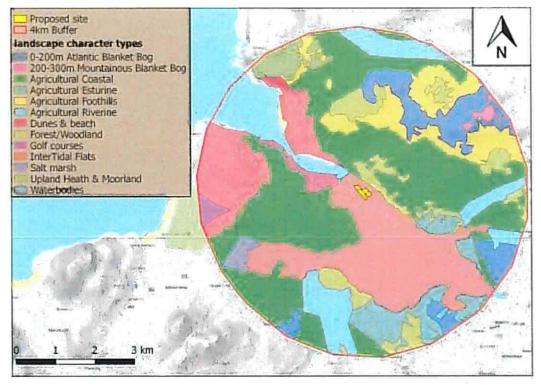
Landscape Character types within 4 km of the proposed site include: Atlantic Blanket bog, Mountainous Blanket bog, a mixture of coastal, estuarine, foothills and riverine agriculture, dunes and beaches, woodland, Golf course, intertidal flats, salt marsh and upland heath/moorland (Figure 4.1) with agriculture being the most dominant land use.

Figure 4.1 Landscape Character types.

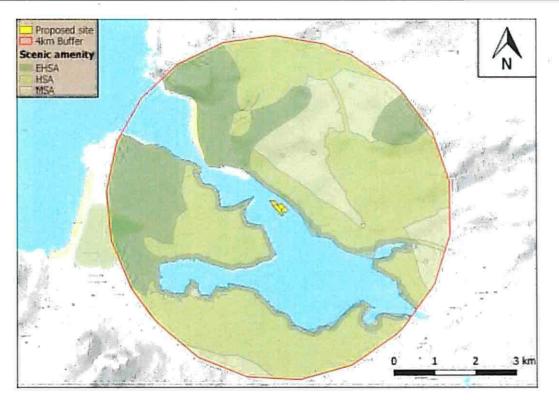
The key coastal uses included farming, fishing, tourism, residential and recreational. The recreational use is around the coast, beaches and golf courses at Ballyliffen. The seascape is used for recreation and tourism, mainly on the beaches as well as the piers where fishing vessels operate. The more sheltered Trawbreaga is used for aquaculture. There is a view point located to the north of the mouth of the estuary at Knocknamany which looks out over Five Finger Strand. Donegal County Council has also mapped the scenic amenity levels of the county, categorised as either areas of Especially High Scenic Amenity, High Scenic Amenity or Moderate scenic amenity (Figure 4.2).

Figure 4.2 Scenic amenity levels within 4km of the Site (Especially High Scenic Amenity (EHSA), High Scenic Amenity (HAS), Moderate scenic amenity (MSA).

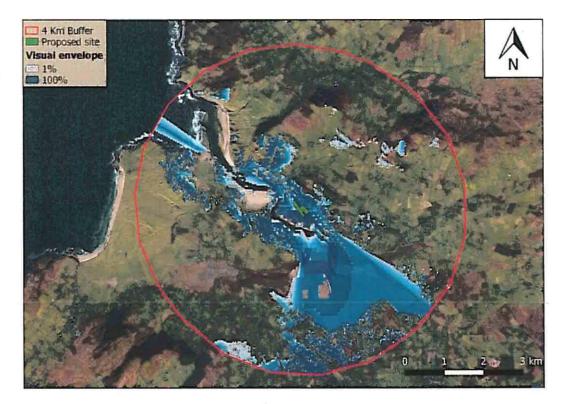
A Visual Envelope Map (VEW) was produced using the Viewshed plugin in QGIS mapping software. The line of sight is calculated using a Digital Terrain Model (DTM) and produces visual representation of the areas that the site can be viewed from. A 30m DTM was sourced from JAXA (Japan Aerospace Exploration Agency). The DTM elevation is expressed in meters above Mean High Water Spring. As the proposed trestles are located on the lower shore a DTM was required for the bathymetry of Trawbreaga bay. As no DTM was available one was produced from the admiralty chart for the area. The VEM was then overlaid on the receptor maps. It is important to note that this method does not take into account the screening effect provided by trees and other vegetation and therefore, the actual visual envelope of the proposed site is likely much smaller than the model predicts.

Figure 5.1 Visual envelope of the proposed site.

The landscape and visual receptors that have been identified are residential properties, National Monuments, a key view point, Wild Atlantic Way, golf courses, beaches and walking trails. Receptors were initially scoped out by using a 4km buffer around the proposed site as per the guidance document. As no evidence of official walking trails could be found within 4km of the site, this receptor is considered screened out and will not be discussed further. The area of assessment was further reduced through the production of a visible envelope for the site using a digital terrain map (Figure 5.1). This highlighted the areas in which the proposed site can be seen in the surrounding landscape and so the only areas that could have any visual impact. The position of each receptor that occurred within the visual envelope was then mapped.

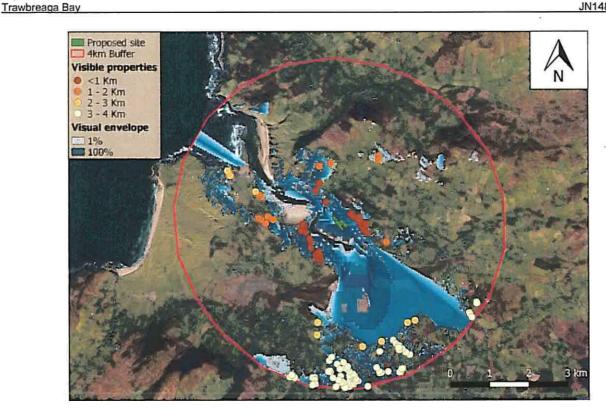
The residential properties located within the visual envelope have been map from satellite images (Figure 5.2). There are 34 properties within 1km of the site, 12 at 1-2km, 11 at 2-3km and 70 at 3-4km. The properties between 2 – 4km are unlikely to have any impact on view due to the size of the site at that distances and screening effect by bushes, trees or other buildings. The site will be more visible from properties <2km away, although this will also be reduced by screening by bushes, trees and buildings. As the proposed site will only be exposed at low water, any visual impact will be further reduced.

Figure 5.2 Residential properties within the visual envelope.

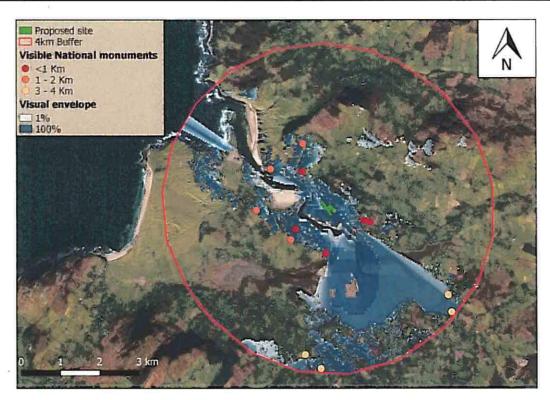
There are a total of 17 national monuments located within the visual envelope (Figure 5.3). There are six within 1km of the site which include a mound, hut site, rock art, flat cemetery, a midden and a standing stone. The closest is the mound at *circa* 740m. There are four monuments between 1-2km a souterrain, a ringfort (unclassified), a standing stone and rock art. There are a further seven monuments at 3-4km which include three holy wells, two standing stones, a souterrain and a burial cairn. Visibility from these monuments is expected to be low due to the screening effect of hedgerows, trees and buildings.

Figure 5.3 National Monuments within the visual envelope.

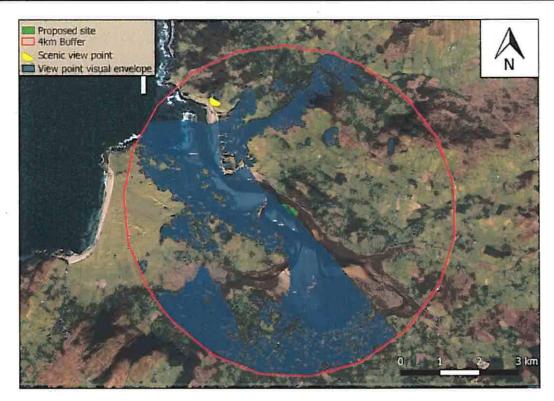
There is only one view point within the 4km buffer which is listed on the draft Donegal County Development Plan 2018-2024. It is located to the north of the mouth of the estuary at Knocknamany and has view across Five Finger Strand. A visual envelope was produced to show the areas which are visible from the viewing point (Figure 5.4). It is noted from Figure 5.4 that the proposed site would be partially visible from the view point at low water. However, as the view point is approximately 3.1km from the site, the partially visible site would have minimal impact of the visible landscape.

Figure 5.4 Knocknamany view point visual envelope.

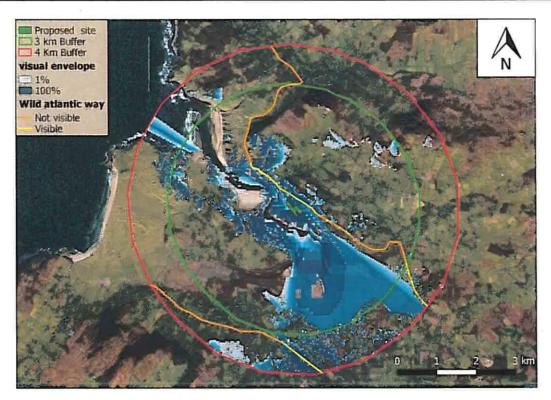
This tourist route passes along the south of the bay along R238 and then along the north of the bay along R242. The areas from which the site will be visible are highlighted in Figure 5.5. The locations greater than 3km from the site will have no appreciable view as it will be broken by hedgerows and buildings while driving. The proposed site would also appear small at such a distance. The main impact will be to the section of the R242 which passes within 150m of the proposed site. The impact will be minimised as the site would only be visible at low Spring tides that occur during hours of daylight. The main scenic views along this section are of the mountains and hills surrounding the area. The proposed site would cause no obstruction to these views due to its positioning on the lower shore.

Figure 5.5 Visibility of the site from the Wild Atlantic Way along R242 and R238

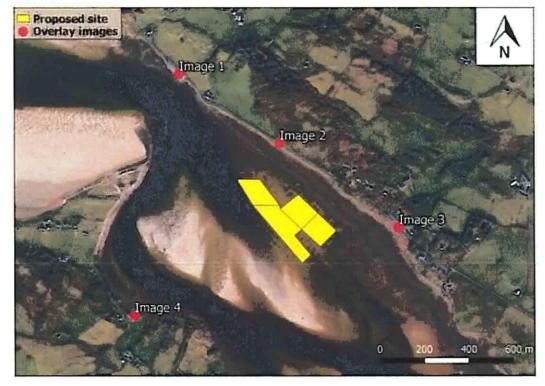
The location of the images taken can be seen in Figure 5.6. All images were taken at low water.

Figure 5.6 Overlay image locations.

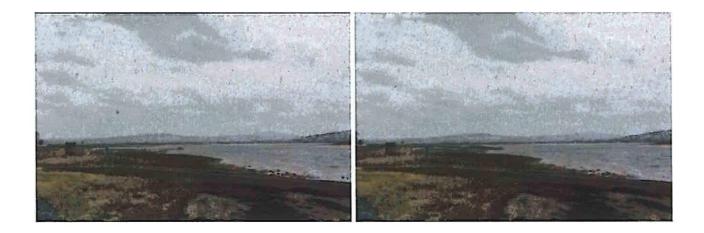
The first overlay is from northwest of the proposed site as viewed from a layby on the R242 (Figure 5.7). The extent of the visibility of the proposed site at low water can be seen in the right hand image. This point is approximately 540m from the edge of the proposed site. The trestles can be seen along the shore on the left had side of the overlay image.

Figure 5.7 Image 1 overlay comparison, original image on the left and overlay on the right. Looking southeast.

The Sensitivity of R242 to landscape and visual amenity impacts associated with the project is considered to be Medium owing to the presence of existing oyster farms and intermittent viewing opportunities because trestles are virtually invisible as they can only be seen at low Spring tides during daylight hours, see Figure 5.5. The Magnitude of change is considered to be Medium due to the size of the visual envelope (Large) and the viewing distance (short-distance). This gives an overall risk Significance of Moderate for the road users but only at low Spring tides during daylight hours. A digital overlay of the project as views from the road 242 is presented in Figure 5.7, Figure 5.8, and Figure 5.9.

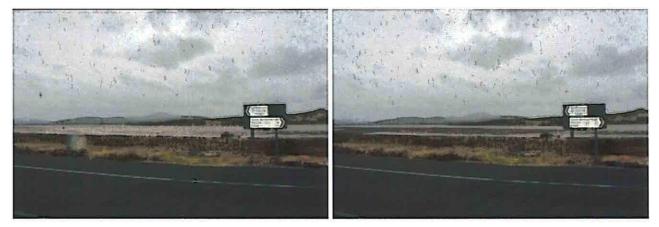
The second overlay is from north of the proposed site at one of the closest points to the road (Figure 5.8). In the image on the right, the trestles can be seen running horizontally along the middle of the image. This point is approximately 180m from the edge of the proposed site.

Figure 5.8 Image 2 overlay comparison, original image on the left and overlay on the right. Looking southwest.

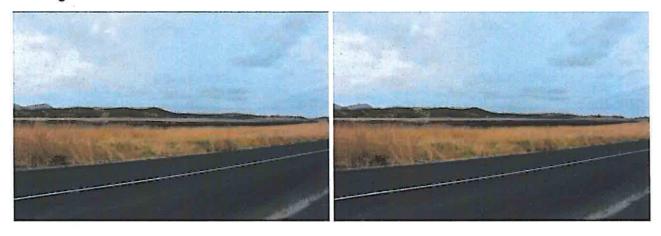
The third overlay image is from the east of the proposed site (Figure 5.9). In the original image without the overlay the existing trestles can be seen on the left hand site. In the overlay image on the right the trestles can be seen as a darkening on the lower shore running horizontally. This point is approximately 280m from the edge of the proposed site. It is noted that the overlay trestles are much more prominent in the images than the existing trestles. Therefore, the visual impact of the proposed trestles will be somewhat less than the images show.

Figure 5.9 Image 3 overlay comparison, original image on the left and overlay on the right. Looking west.

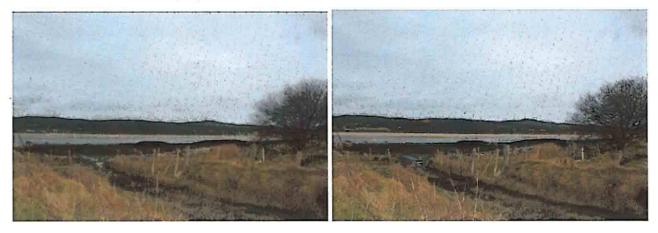
The fourth overlay image is from the west of the proposed site on the southern site of the bay (Figure 5.10). The trestles are barely visible from this point on the right hand side of the image. This point is approximately 730m from the edge of the proposed site.

Figure 5.10 Image 4 overlay comparison, original image on the left and overlay on the right. Looking northeast.

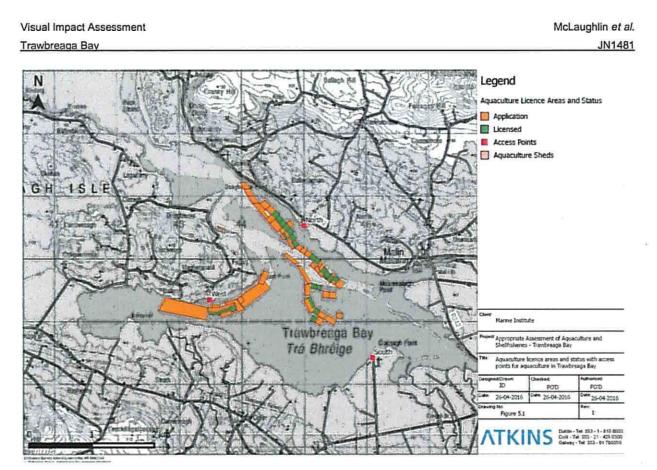
In 2016, there were 25 existing licensed aquaculture sites and 42 determinations for new site applications or renewals. Of the 25 existing aquaculture sites, 22 are located in the West side of Trawbreaga Bay and of the 42 new applications, 34 are located in the same area of the bay (Figure 6.1). The 4 new sites that are the subject of this visual impact assessment are also in the western part of Trawbreaga.

Figure 6.1 Map of current licenced aquaculture and applications.

The total extent of Trawbreaga Bay is 10.03 km². The area that is currently licensed and that for which licenses are being sought represents 7.5% of the total bay area, while the project sites (T12 / 475, T12 / 471, T12 / 434 and T12 / 426) only represent 0.58% of the total bay area. The cumulative impact for these 4 sites is considered medium, as the distance from the sites to other sites is short: the closer sites are to one another, the lower level of visual intrusion. As existing foreshore access routes (Figure 3.1) will be used, no construction or operational impacts need be considered in this cumulative impact assessment.
